The usual symptoms of a Transmission Lifters with air in system are as follows;

Bleeding Instructions

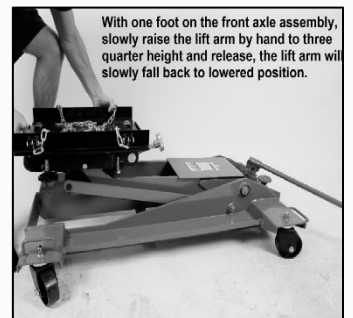
1. Remove the Filler Bung and if required, refill with *32 Grade Hydraulic until the oil is approximately 6mm below the filler hole then replace the Filler Bung.
2. Leaving the Pump Handle in the lowered position, open the release knob one eighth turn anticlockwise.
3. With one foot on the front axle assembly, slowly raise the lift arm by hand to three quarter height and release, the lift arm will slowly fall back to lowered position
4. Remove the oil filler bung from the top of the hydraulic ram and turn the release valve anticlockwise to open.
5. Replace the filler bung and pump the handle up and down quickly several times to bleed air from the pump system
6. Recheck the hydraulic oil level and refill to 6mm below the fill port if required before replacing the filler bung
7. If necessary, repeat the process steps 2 to 6.

At this point both the Pump and Lift Ram should be free of air and the Jack ready for operation.
